Subject: April 28, 2014 Inspection Report

CAFO WPDES Compliance Report (06-17-14)

Operation Name: New Horizons Dairy LLC

WPDES Permit No. WI-0063428-02-0

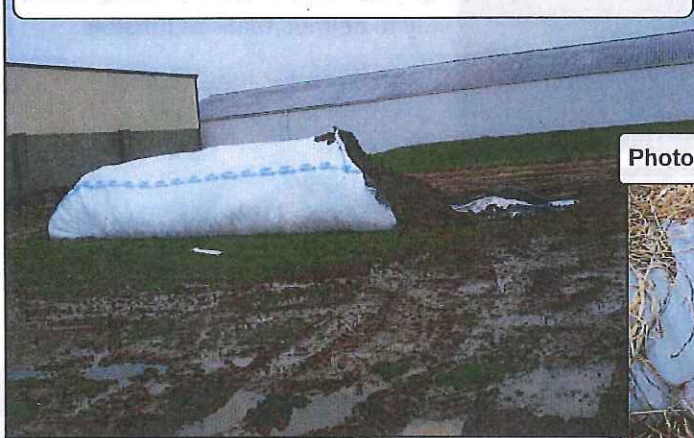
Feed Storage and Leachate Collection—Surface runoff from bean silage (Photo 1) flowed SW under the gravel drive through a culvert (Photo 2) into the grassed waterway (Photo 3). Several nutrient-burn pathways were

Photo 1. Bean silage stored in grassy area along southern border of production area (facing NNW from gravel road).

the grassed waterway. VanDeHey stated that runoff from the feed storage area is prevented through operating practices. Burdett encouraged additional collection of waste feed. VanDeHey agreed, and said that he will remind his staff of the importance of this task.

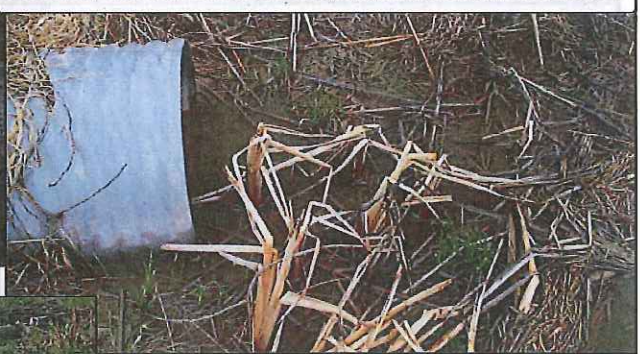
Photo 2. Close-up of culvert accepting runoff from bean silage.

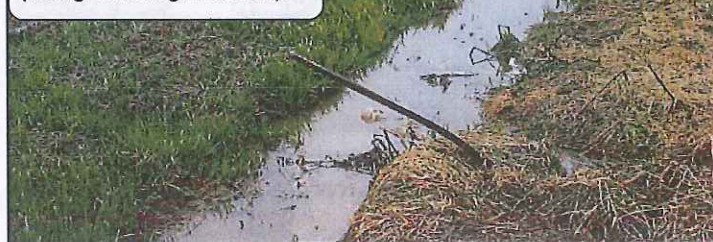
observed from the feed leachate pad traveling SE to the grassed waterway (Photo 4). Burdett and Atkinson collected water samples from the grassed waterway directly downstream of the nutrient-burn pathways for laboratory analysis. No signs of vegetation burn-out were seen in

Photo 3. Grassed waterway SSE of feed storage pad (facing W from gravel road).

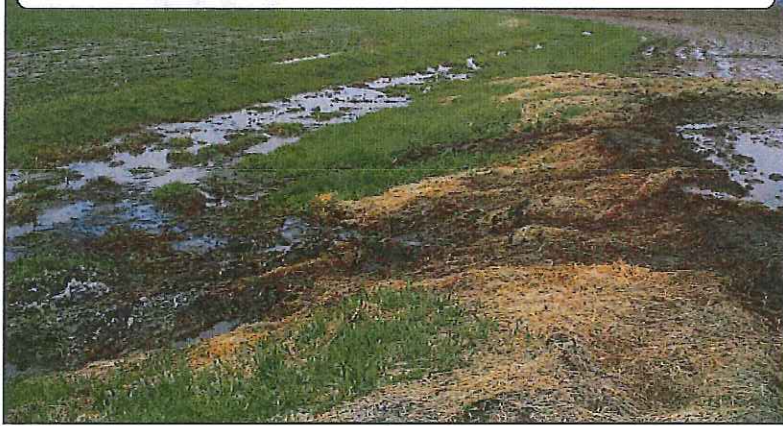
Photo 4. Nutrient burn pathways (facing SW from the S edge of feed leachate pad).

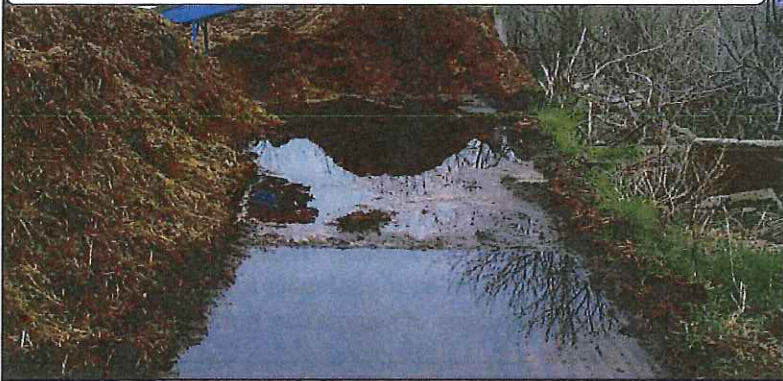
Photo 5. Bedpack solid manure in the NE corner of the production area (facing north).

Bedpack Stacking—Solid manure was present in a semi-confined stack near steep slopes (Photo 5). The stack was on a concrete pad partially surrounded by concrete walls (walls not visible in Photo 5). Runoff was not observed at the time of inspection. Burdett, Atkinson, and Uvaas advised that measures be taken to avoid runoff. VanDeHey suggested moving the material to the facilities manure storage pit or stacking it on approved fields once conditions allow. Uvaas stated that either action would be a solution.

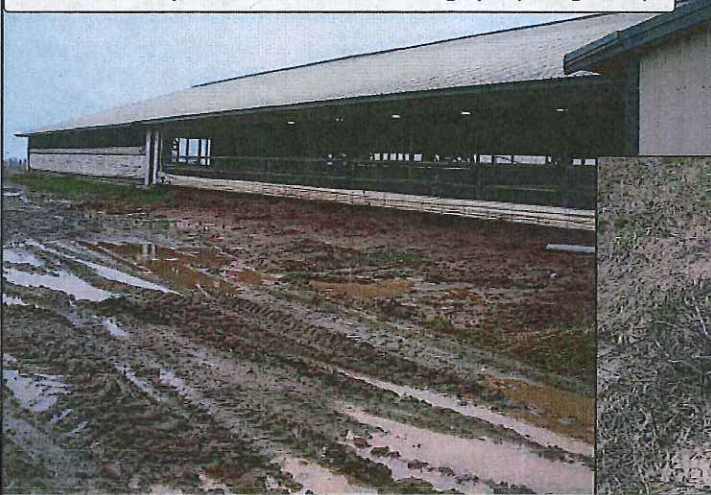
Photo 6. Muddy area SE of manure storage pit (facing north).

Erosion Control—During the inspection Burdett, Atkinson, and Uvaas noted several areas (Photo 6-7) in need of erosion control measures. They also acknowledge recent successful re-seeding in parts of the pasture. VanDeHey stated that he will speak with his staff about operating machinery during wet conditions, reminding them to stay to defined roads as possible.

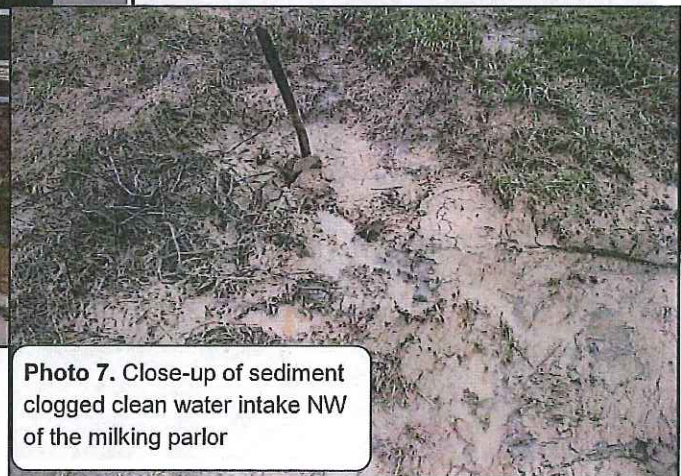
Photo 7. Close-up of sediment clogged clean water intake NW of the milking parlor
